TECHNICAL DOCUMENT TO SUPPORT NO FURTHER ACTION DECISION FOR SITE SS17-BUILDING 102

KOTZEBUE LONG RANGE RADAR STATION, ALASKA

JULY 1995

TETRA TECH INC. 15400 NE 90th, Suite 100 REDMOND, WA 98052

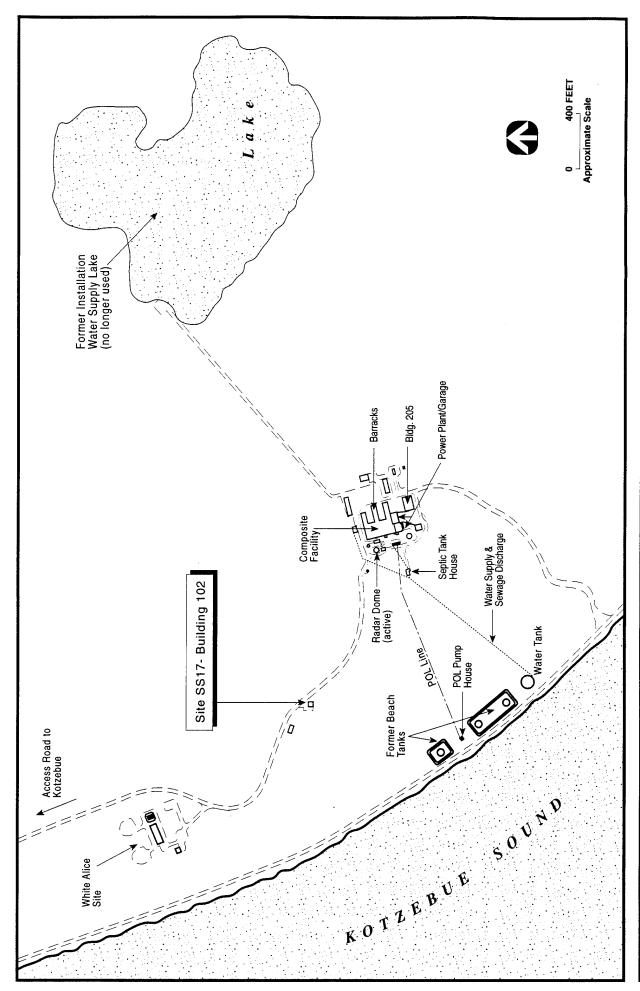
Location of Site SS17-Building 102, Kotzebue LRRS, Alaska. Figure 6.

Site SS17-Building 102 is a 72 square foot area of stained soil, located in a gravel driveway at the Navigational Aid Building (Building 102). Site SS17 was formally identified by the USAF based on preliminary PCB field screening results which identified PCBs in stained soil. However, subsequent analytical results for soil samples collected from the stained soil do not indicate the presence of PCBs at the site. It is suspected that elevated concentrations of petroleum hydrocarbons interfered with the PCB field test kits, causing a false positive result. The area of stained soil at Site SS17 is included in the characterization of Site SS16-Navigational Aid Buildings; therefore, no further action is recommended at Site SS17. A No Further Action Decision Document will be prepared for Site SS17.

Site SS17 is an area of stained soil approximately 6 feet by 12 feet, located in a gravel driveway at the Navigational Aid Building No. 102 (Figure 6). The area of stained soils extends from the gravel drive entrance to the edge of the facility access road. This site is incorporated in the characterization of Site SS16-Navigational Aid Buildings.

Analytical results did not indicate PCBs are present in the stained soil associated with Site SS17. The area of stained soil at Site SS17 is included in the characterization of Site SS16-Navigational Aid Buildings); therefore, no further action is recommended at Site SS17.

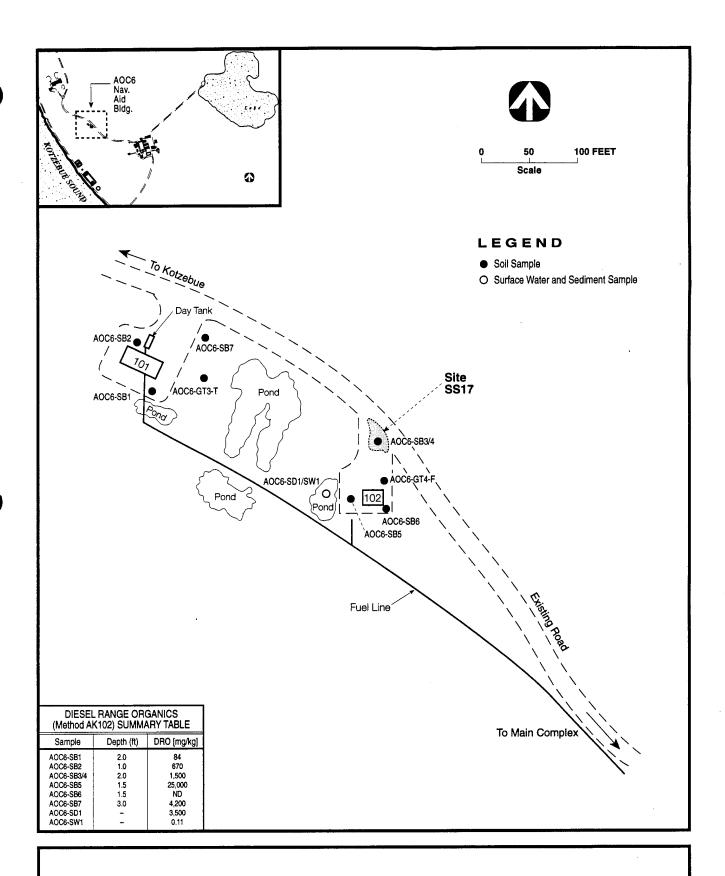
Figure 7. Location of Sample Stations at Site SS17-Building 102 (AOC6), 1994 Remedial Investigation, Kotzebue LRRS, Alaska.

During the 1994 RI, two surface soil samples were collected from within an area of stained soils approximately 6 feet by 12 feet, located at the Navigational Aid Building No. 102 (Figure 7). The samples were screened for PCBs using Dexsil CLOR-N-SOILTM field test kits. The PCB field test kits provide a colorimetric indication of PCB concentrations equal to or greater than 50 mg/kg in soil. Field screening results detected PCBs in both soil samples collected from the stained soil. Based on these preliminary findings, the USAF formally identified the area of stained soils as Site SS17-Building 102.

During the 1994 RI, a soil sample (AOC6-SB3) was collected from the area of stained soil at Building 102 (see Figure 7). Sample AOC6-SB3 was analyzed for diesel range organics (Method AK102), volatile organic compounds (EPA Method SW 8260), semivolatile organic compounds (EPA Method SW 8270), and pesticide and PCBs (EPA Method SW 8081). No PCBs were detected in Sample AOC6-SB3. It is suspected that the petroleum hydrocarbon contamination found in stained soils interfered with the PCB field test kit, causing false positive results. A summary of maximum detected concentrations identified in the single soil sample collected at Site SS17 is provided below:

State and federal ARARs established to guide the 1994 RI are at least as stringent as those criteria developed during previous IRP investigations at Kotzebue LRRS (see RI/FS Report; USAF 1995a). Petroleum hydrocarbon contamination in gravel fill material is the only environmental concern at the site. Diesel range organics were detected in Sample AOC6-SB3 at 1,500 mg/kg, exceeding the 1,000 mg/kg ADEC soil target level established for Kotzebue LRRS.
